**Coalition for a
Better St Catharines**

Visual Evidence of Asbestos at the Former GM Property

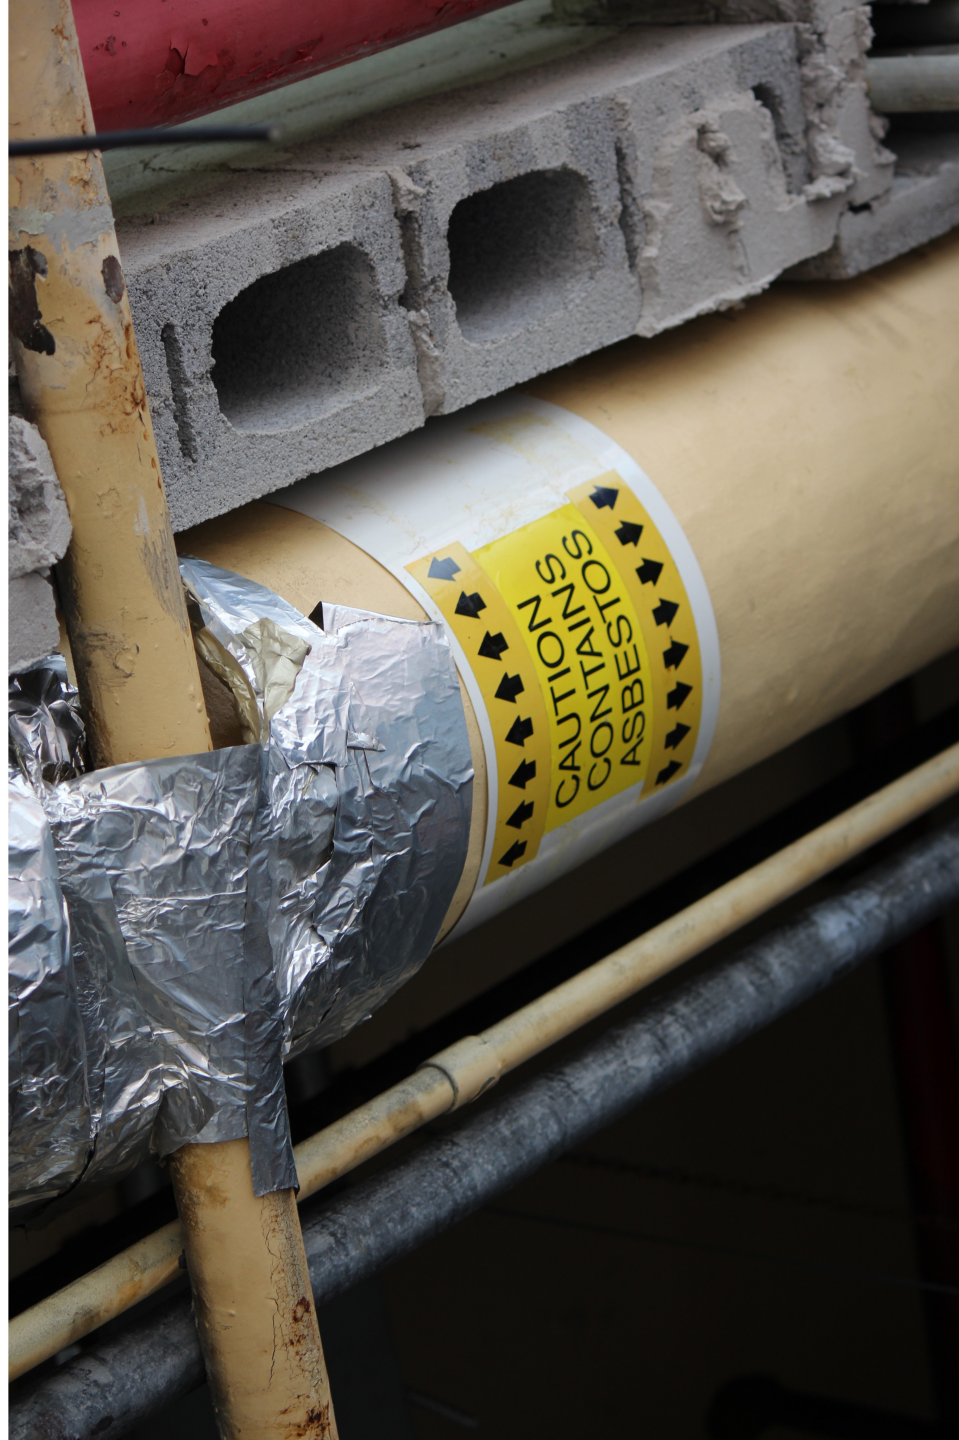
Asbestos abatement has
not been completed.
Asbestos wrapped pipes
are still in place.

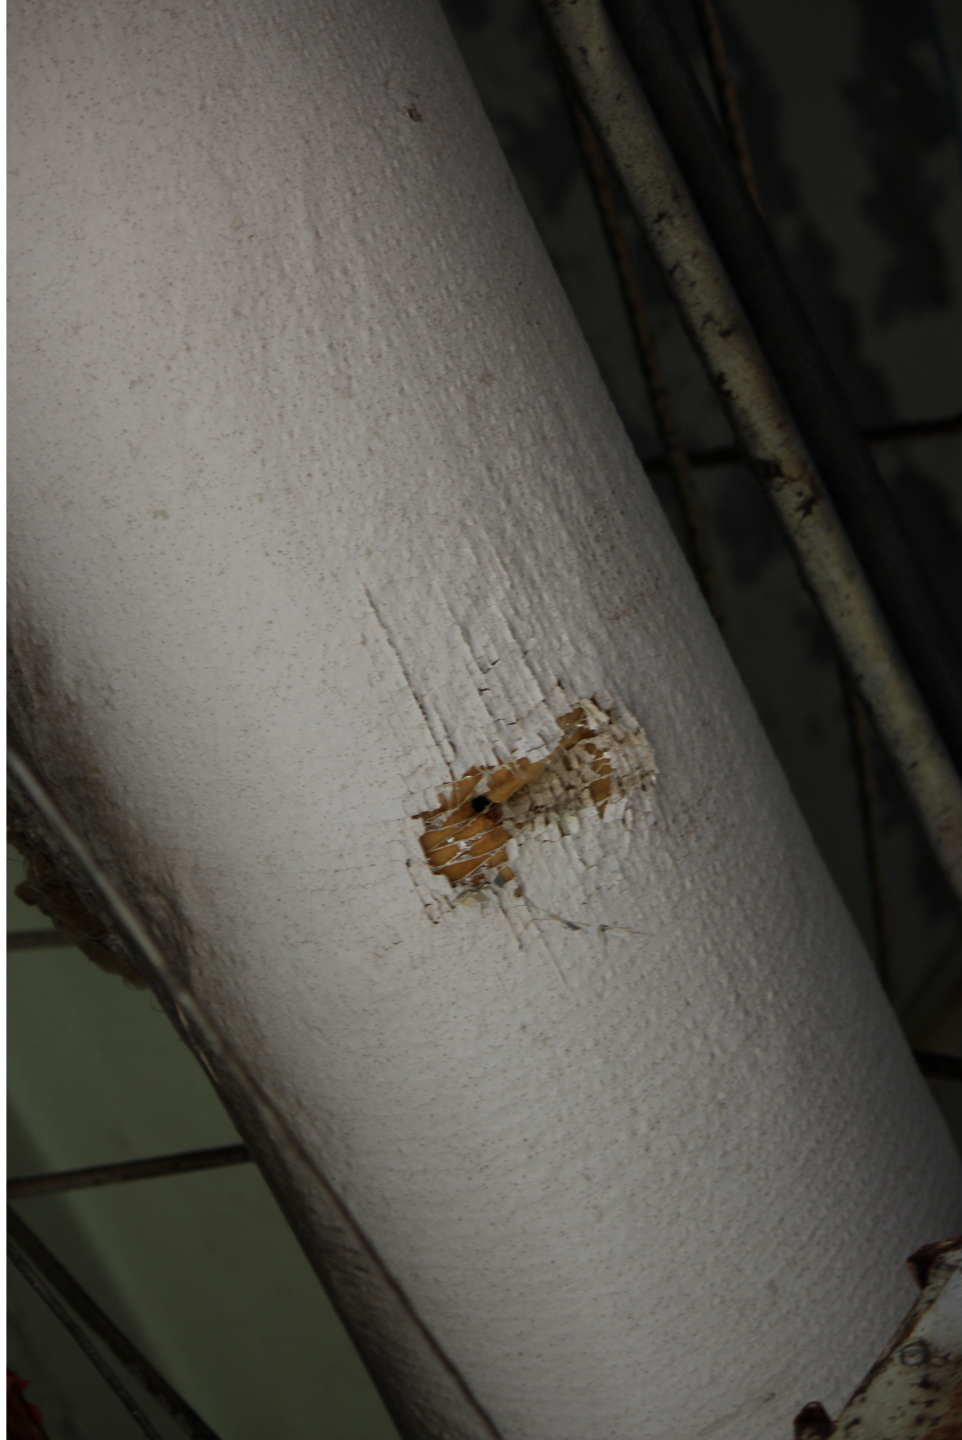
Asbestos wrapped pipes
are damaged in many
places.

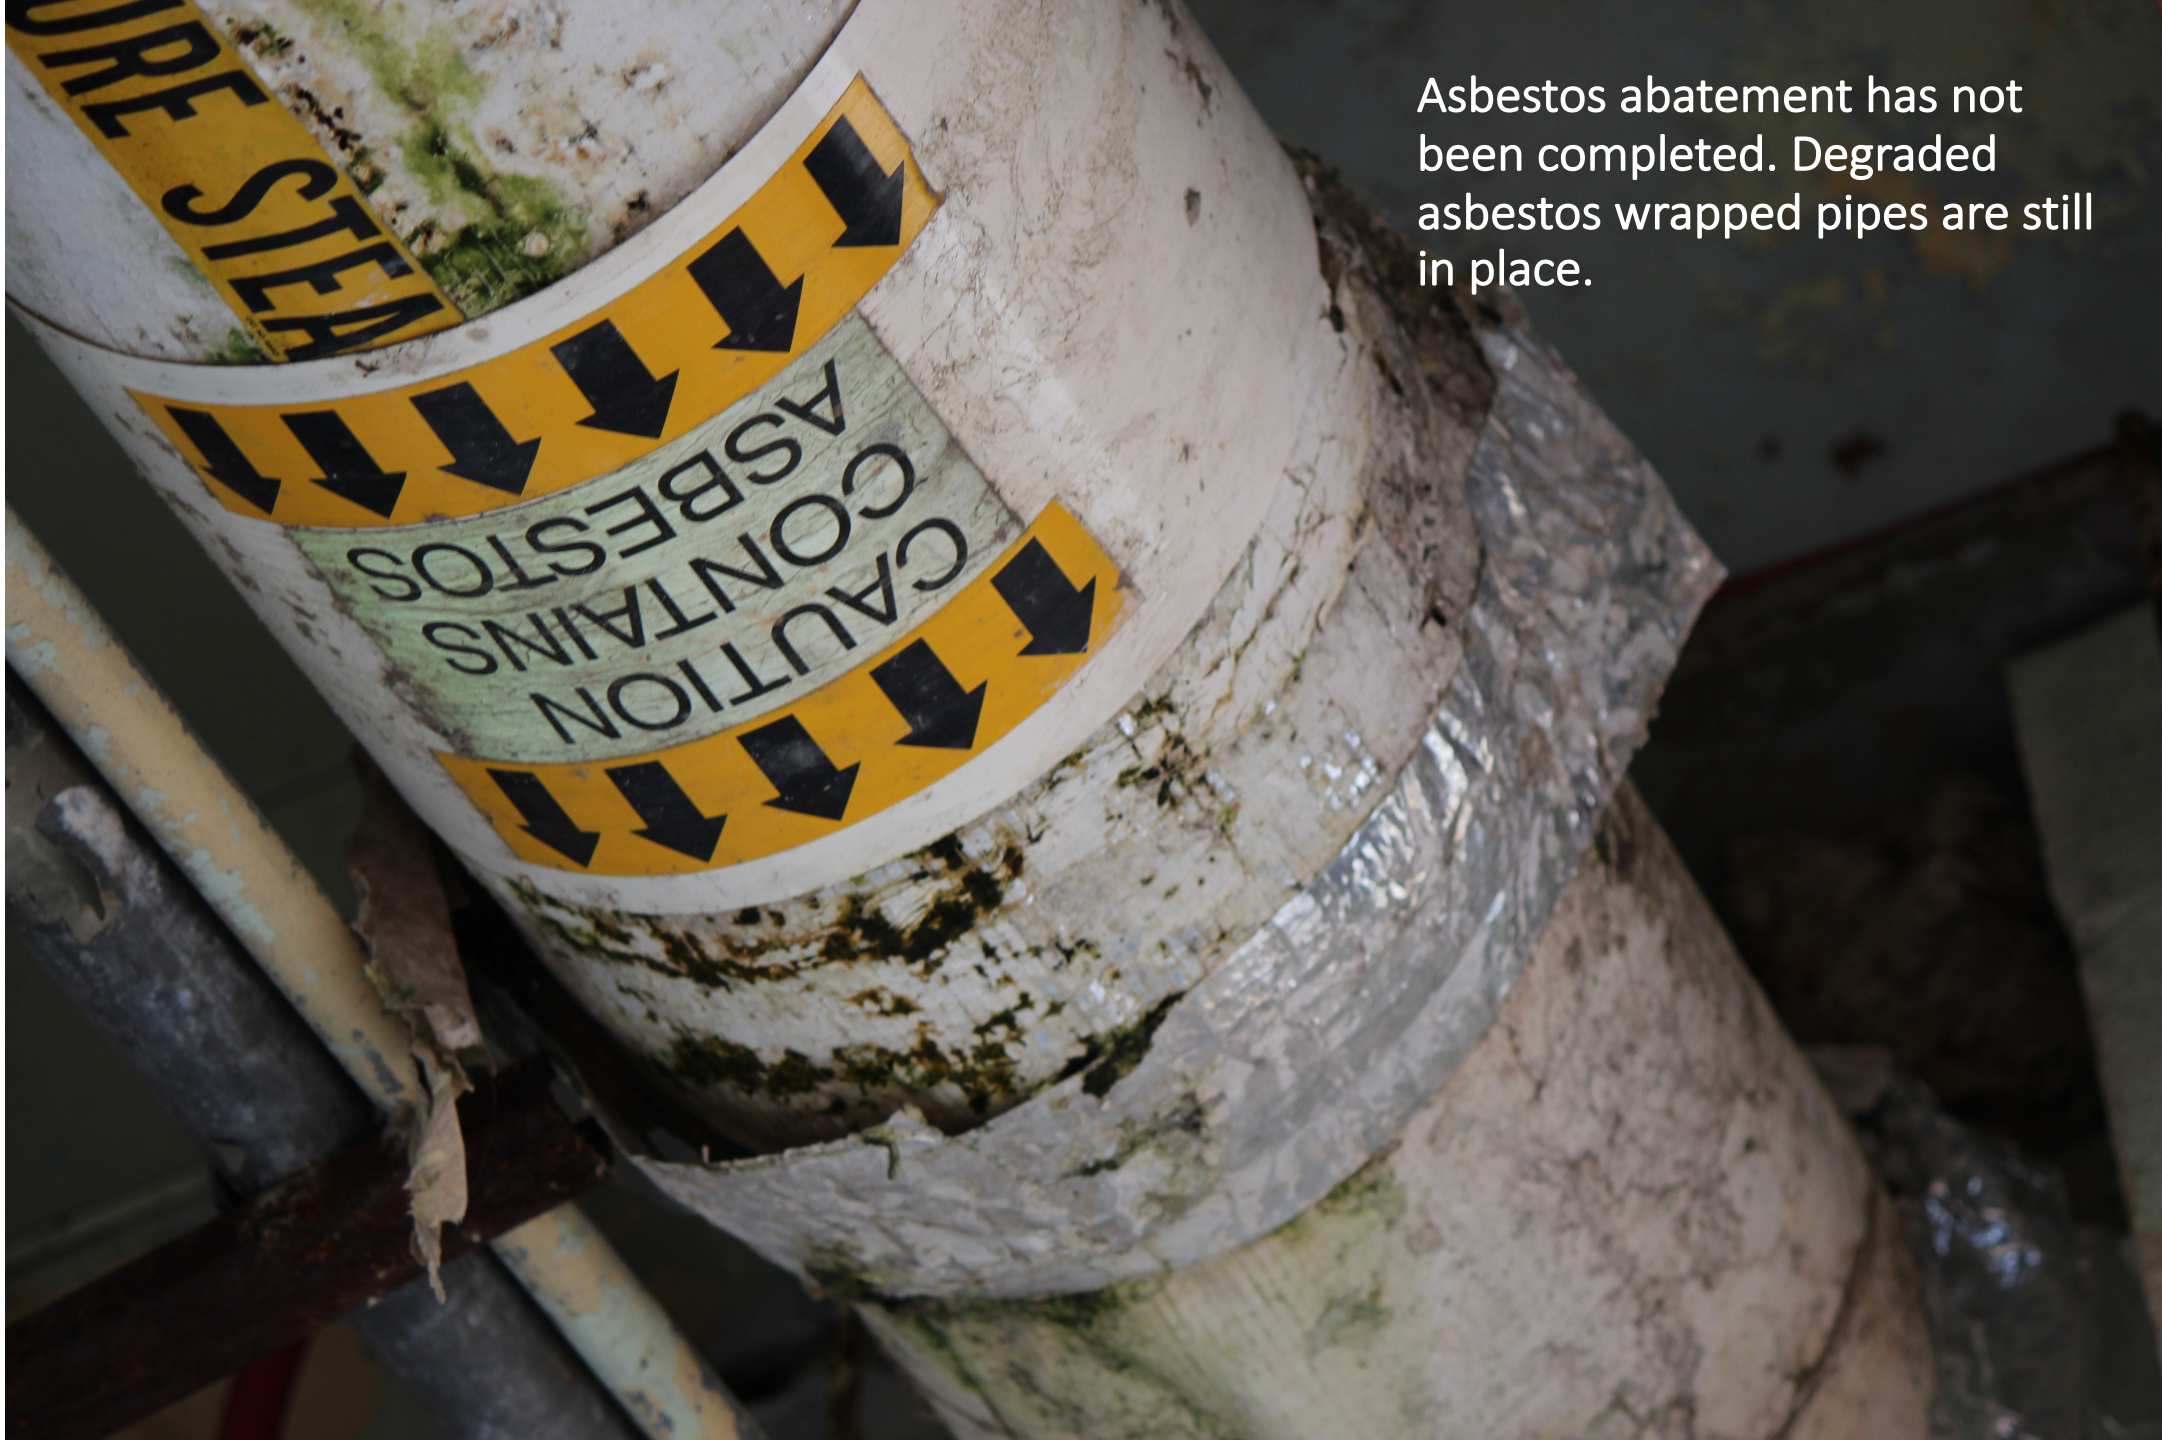
Asbestos abatement has not been completed. Degraded asbestos wrapped pipes are still in place.

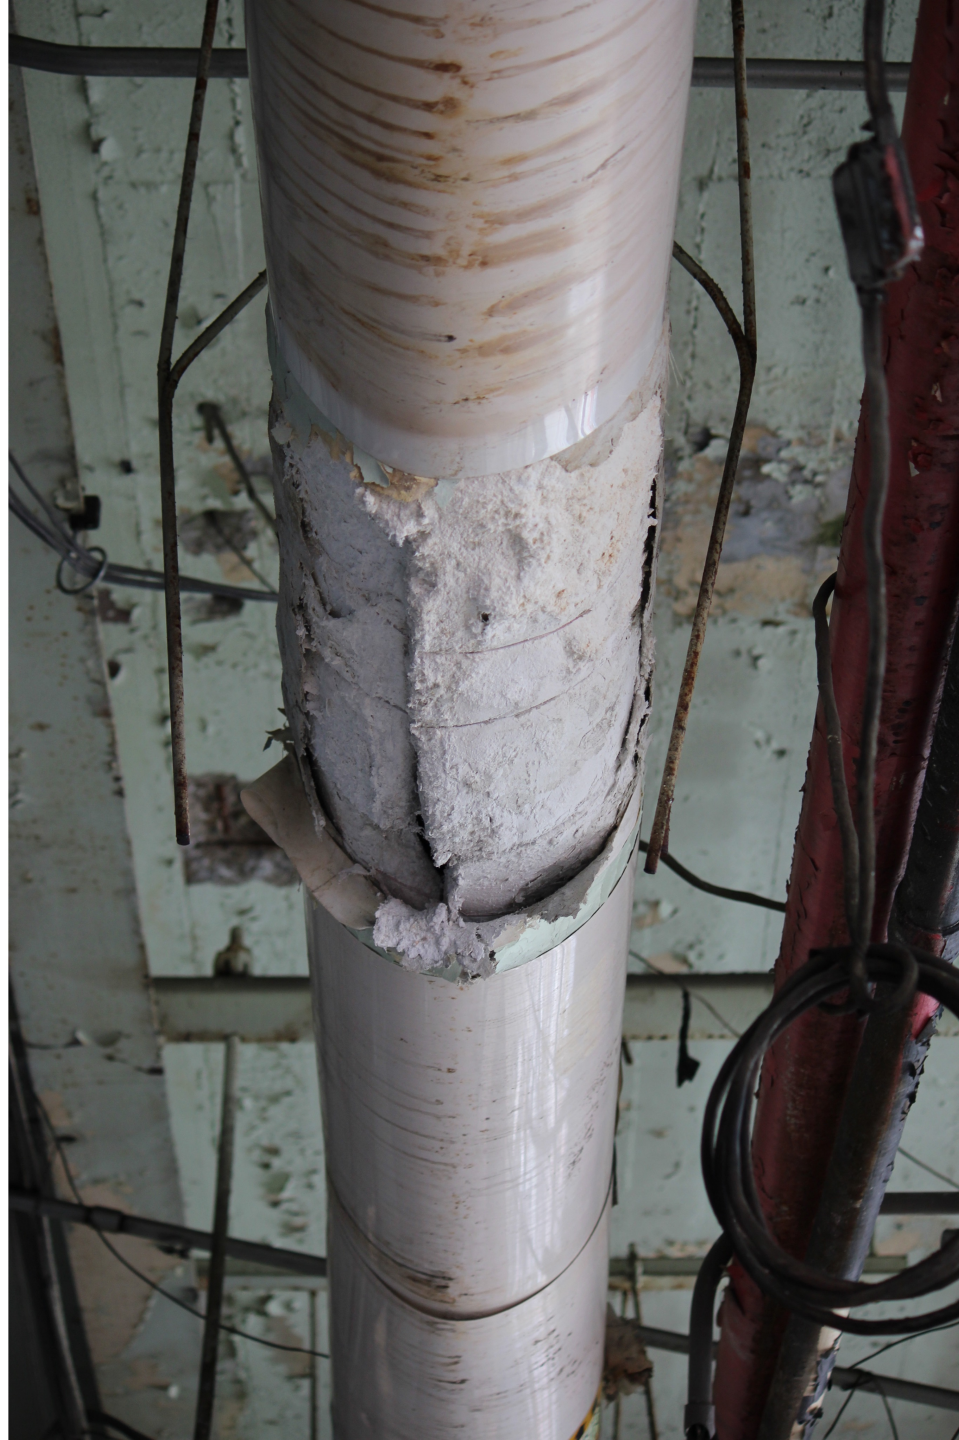
Asbestos abatement has not been completed. Exposed asbestos wrappings are evident in several buildings.

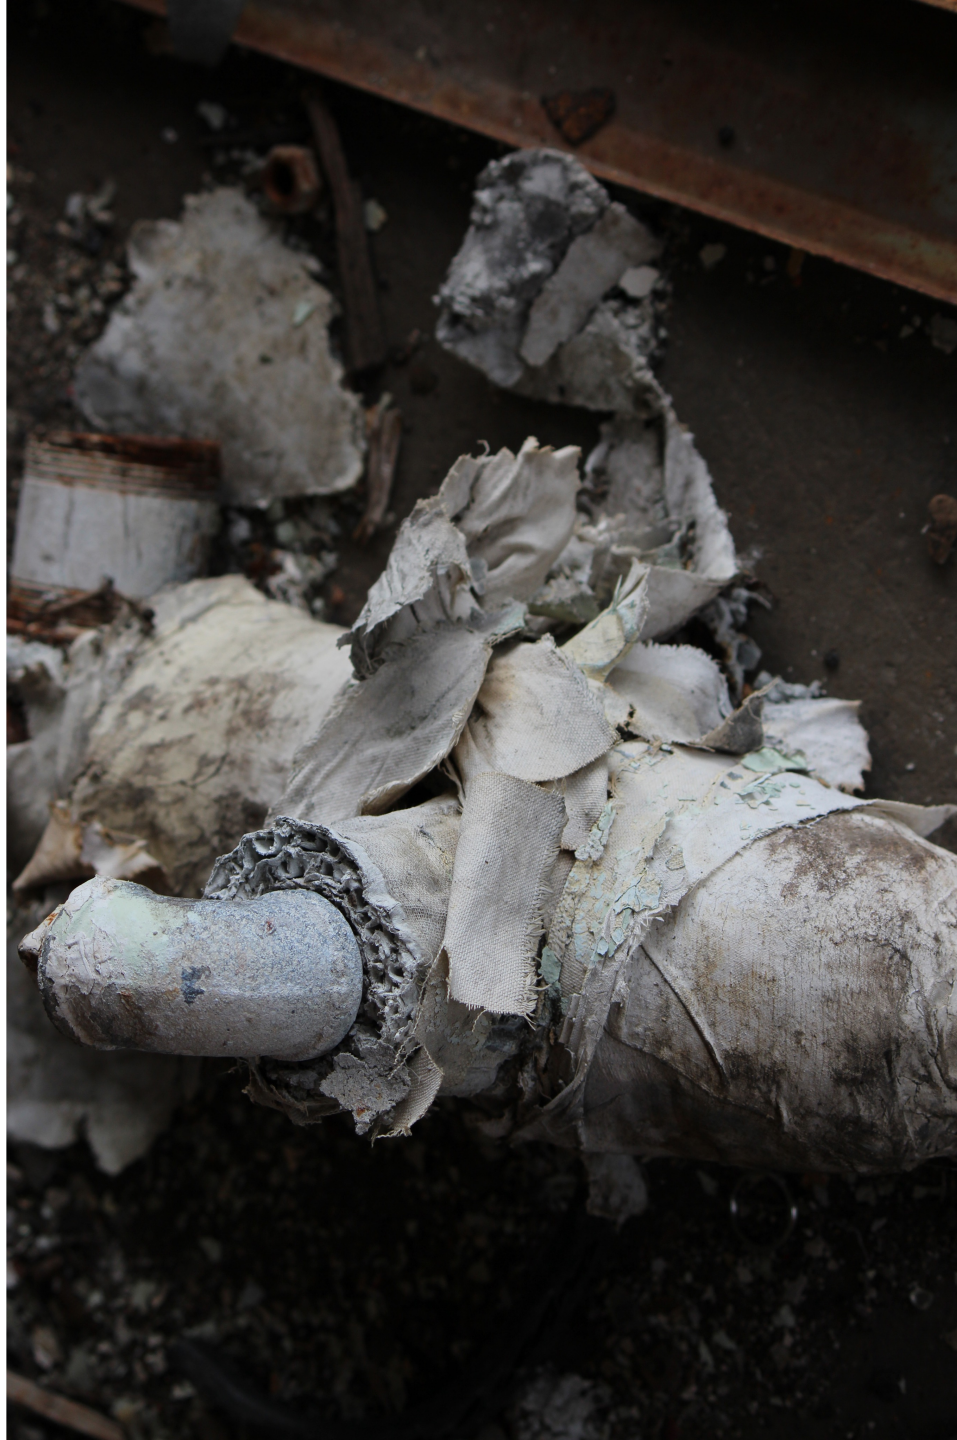
An elbow joint wrapped in asbestos lies on the ground on the west side of Ontario Street.

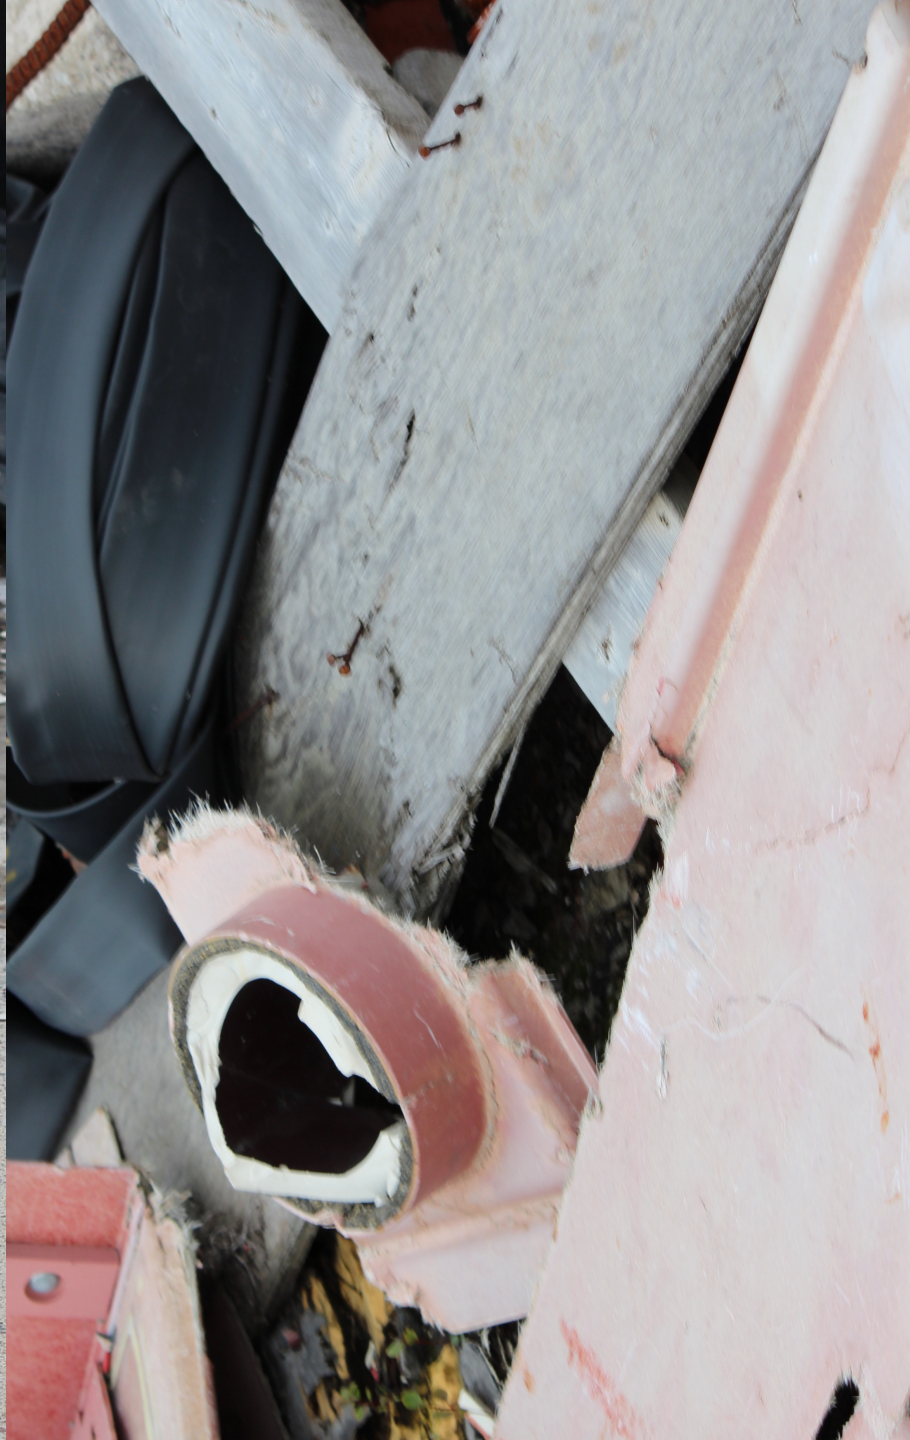
Possible asbestos-based
fibrous building material in
this debris pile.

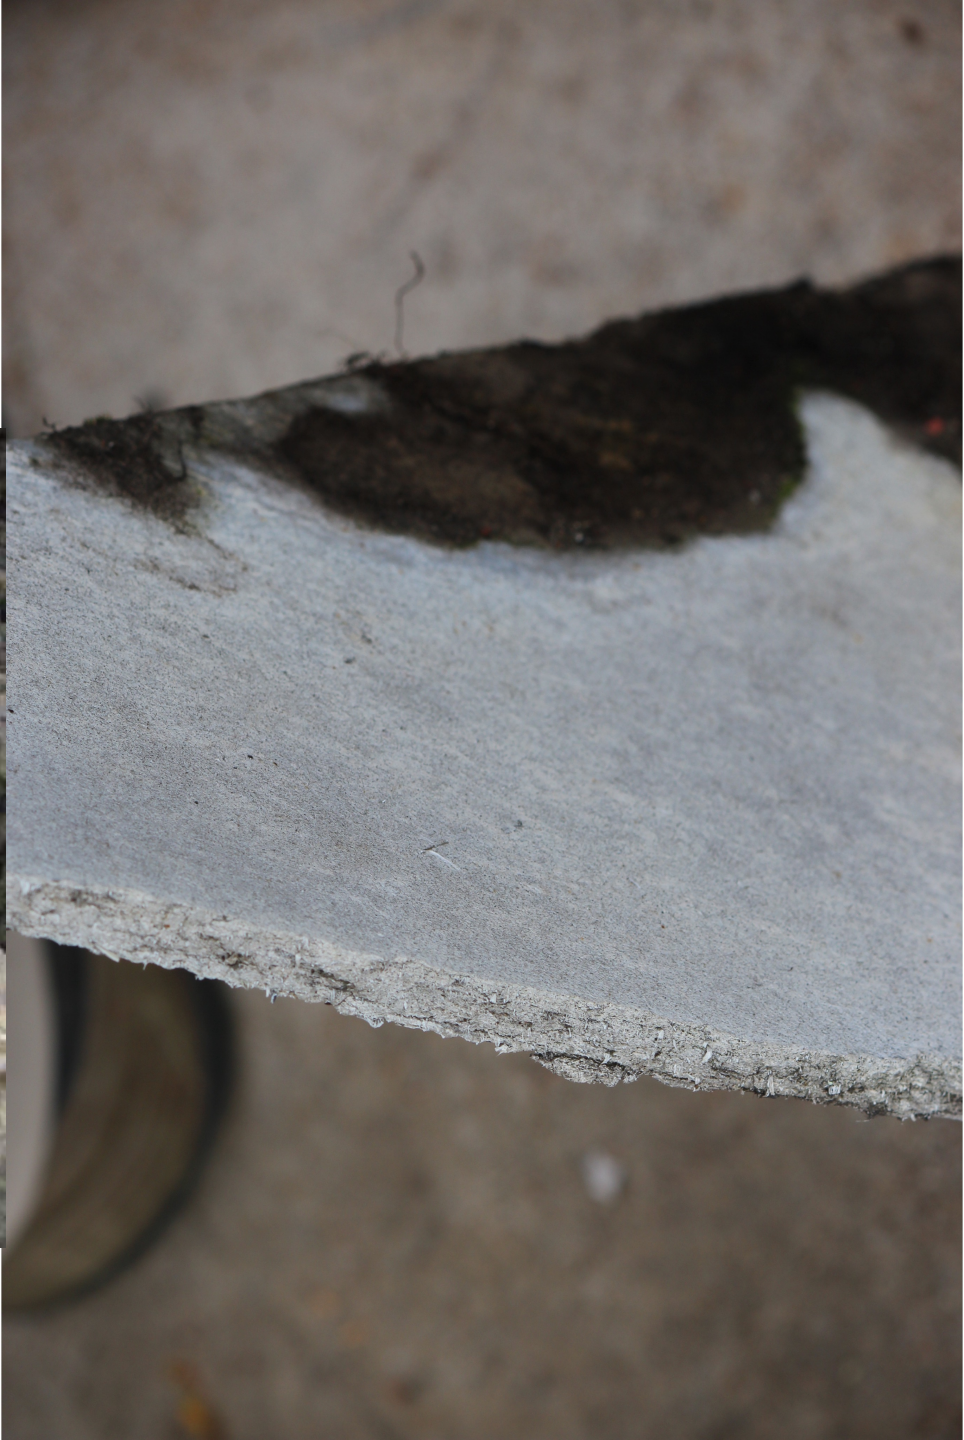
Suspected asbestos fibreboard at the GM site
on the right.

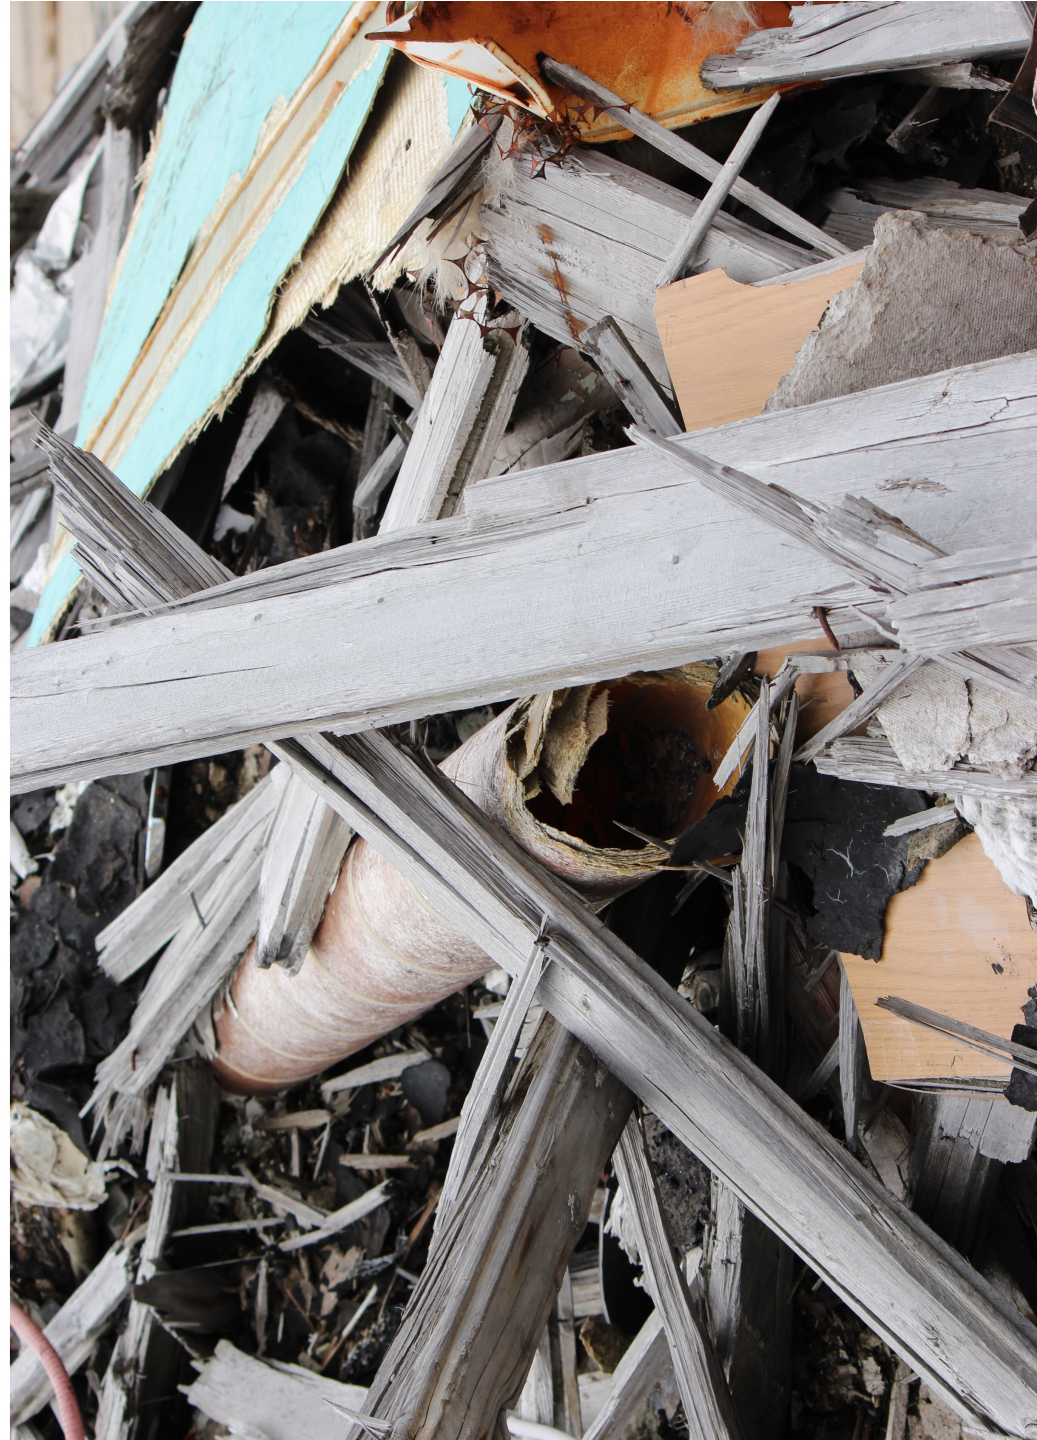
EACO photo of asbestos pipe on the left
On the right is suspected asbestos pipe
in one of the GM Property debris piles.
