MEMORANDUM

DATE: August 25, 2020

TOPIC: **Review of land near 282 Ontario Street, St. Catharines ON**

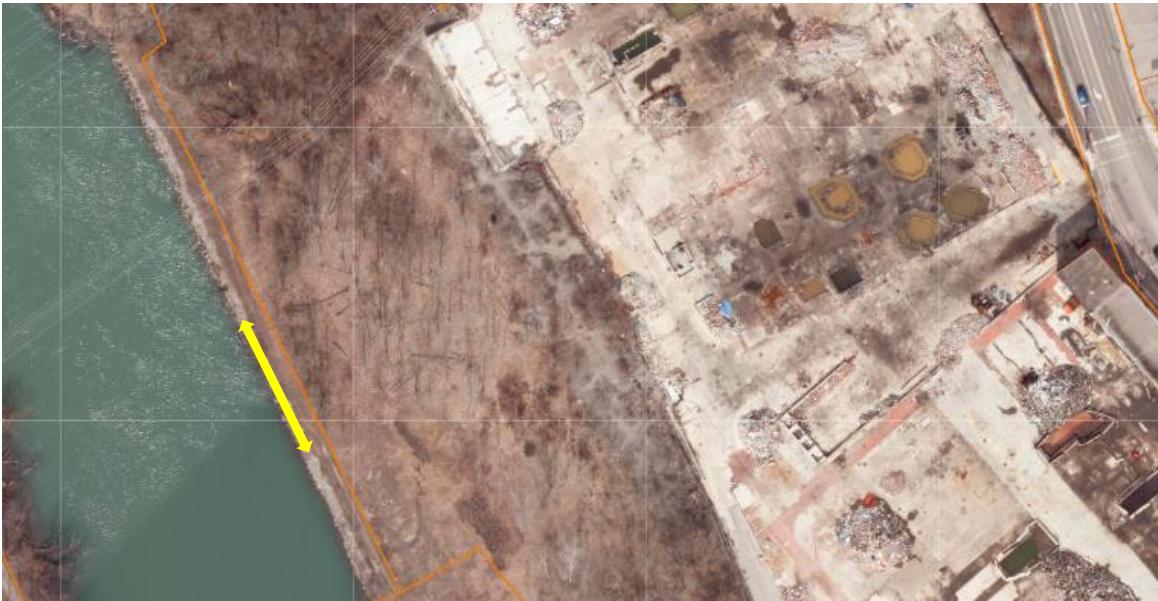
Figure 1: View of the lands near 282 Ontario Street in proximity to TMC. Property lines are marked with the orange lines. These lines show a public bike path exists along TMC (marked with the yellow arrow). Image sourced from public database (<https://www.niagararegion.ca/exploring/navigator.aspx>).

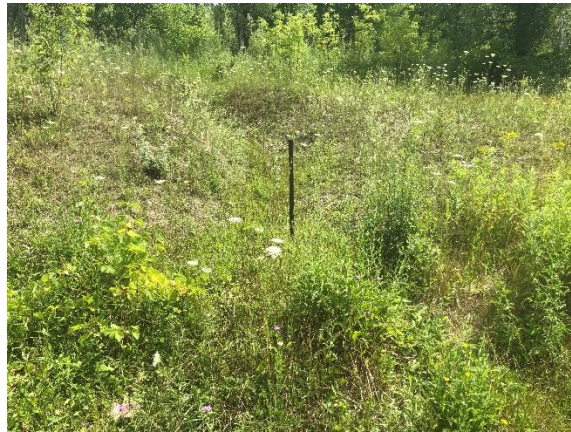
During the inspection, the drainage channels identified within the aerial photographs (Figures 1 and 2) were found and photographed while standing on or near the public bike pathway. These drainage channels exist on the sloped shoreline and extend to the bike pathway, ultimately draining to TMC. These channels are each about 1 m wide (Plates 1 and 2). Generally live vegetation exists along the edge of the channels and are limited to tolerant weeds with sparse density and bare soil in the channels. As well, trees that grow near the channels show dead branches along the channel, suggesting the roots near the channel are stressed and possibly dead even though the soil is intact (Plate 3).

This pattern suggests transport of chemicals from the drainage channel to the roots of the nearby trees along the drainage path to TMC. We observed the presence of white particulate residues in the channel, with sparse vegetation in the channel, and dead branches on woody stems near the channel. These observations collectively suggest runoff to TMC contains contaminants that are causing the noted white particulate residues, low plant diversity, limited distribution of plants, bare soil, and adverse effects (dead branches) in local vegetation. Since this pattern indicates an association with drainage, a more detailed follow up study would be appropriate to ascertain the contaminant(s) that are the likely causative factor(s) for the observed soil and vegetation effect patterns. The presence of disturbed/ distressed vegetation along drainage to TMC also indicates these contaminants are likely entering TMC, with unknown consequences on wildlife and human health. Chemical analysis of the particulates in the dry channels could identify the type(s) of chemicals in drainage during wet periods.

Plate 1: View of drainage channel looking upslope, marked with metal stake, that is about 1 m wide and about 0.5 m deep. Plants are sparse in the channel but grow along the edge, and thereby obscure the presence of bare soil in the channel. This channel corresponds to the location marked by blue arrow 1 in Figure 2.

In this regard, field studies to identify and quantify the contaminants that may exist along the shoreline of TMC associated with the vegetation stress associated with drainage channels is warranted. In conjunction with a review of existing chemical monitoring data for the Site and off-Site areas, such work would improve identification and quantification of loadings of contaminants both in the past and during the period between completion of Stage 1 and the commencement of Stage 2. For example:

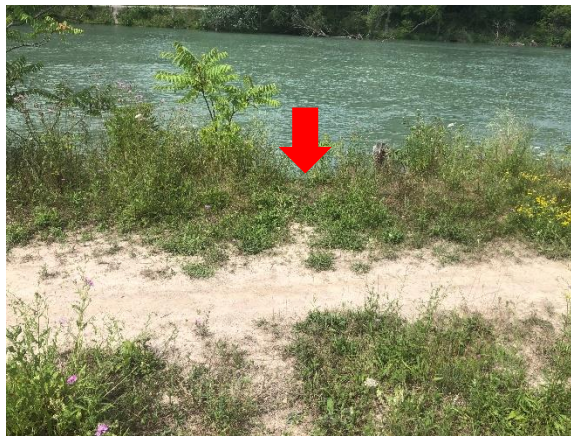
Plate 2: View of drainage channel in Plate 1 looking downslope to public bike path and drainage to TMC (red arrow). This channel shows bare soil with sparse plants in the general area, marked by blue arrow 1 on Figure 2.

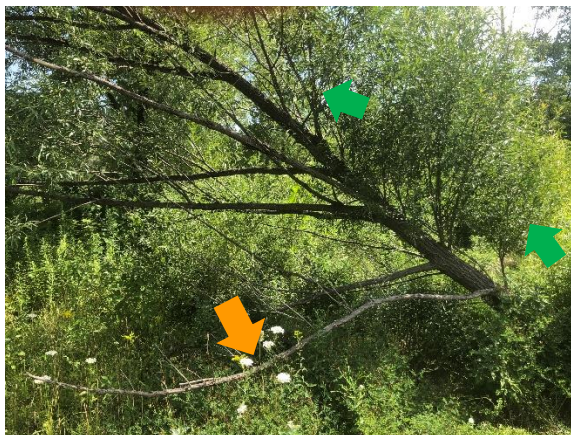
Plate 3: View of Willow (*Salix* spp.) growing next to drainage channel, upslope of view in Plate 1. Note how most branches over the drainage channel are dead (orange arrow) whereas the branches on the opposite side of the trunk are green and seem healthy (green arrows). This pattern implies roots near drainage channel are dead.
